# INDUSTRIAL WORKS IN ZOLA PREDOSA

## NEW INSULATION AND WATERPROOFING USING MAPEPLAN SYNTHETIC MEMBRANE IN A MANUFACTURING FACILITY IN CENTRAL ITALY

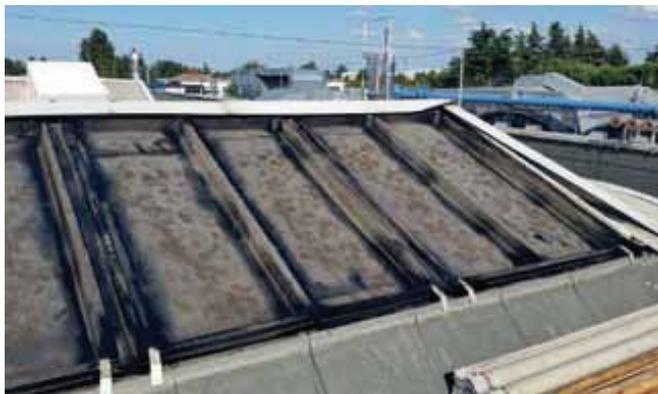
**APPLICATION OF POLYVAP RADONSHIELD VAPOUR BARRIER**

The old wooden elements and mineral fibre insulation on the covering beam connectors and fibre-cement saw-tooth pitched roofs were removed and disposed of at an authorised waste disposal site, in line with the current legislation. A new POLYVAP RADONSHIELD bituminous membrane reinforced with aluminium strip was then applied, which acted as a vapour barrier and temporary waterproofing layer while the old system was removed. All work was carried out with the utmost care to make sure there was a water-tight seal between the new waterproofing and the old bitumen membrane and a constant air-tight and vapour-tight seal at the interfaces between the beams, connectors and saw-

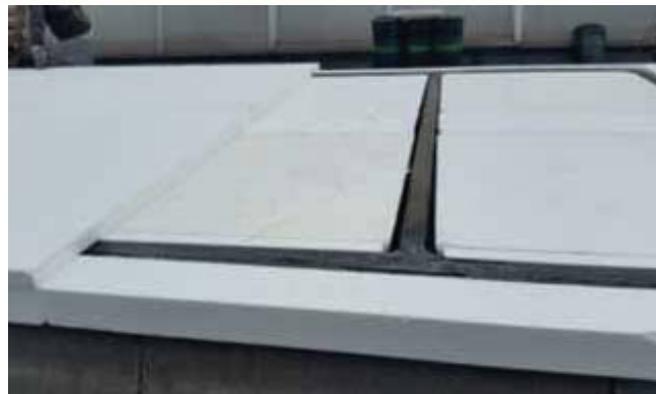
**APPLICATION OF EPS INSULATING PANELS**

New 175 mm thick EPS 150 kPa insulating panels were installed over the connectors and saw-tooth roof. Double layers were applied in these areas; the first layer was used to fill the areas between the ribs for the beam connectors and saw-tooth roof, the second layer to form a continuous cover over the connectors and saw-tooth roof and to eliminate any thermal bridges at the beam/connector/roof interfaces. Both layers of panels were anchored to the substrate with a mechanical fastening system. In this case, MAPEPLAN T M FPO waterproofing membrane was applied over the insulating panels.

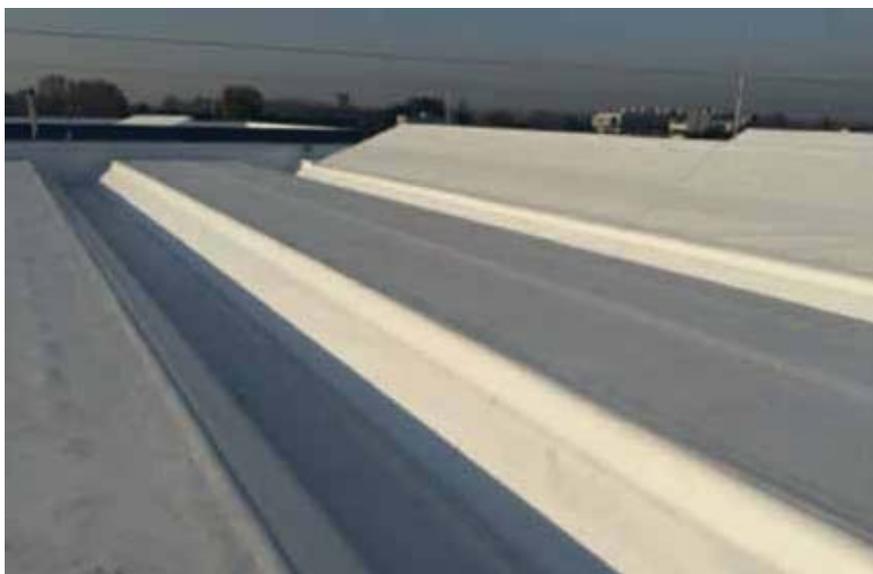
**THE ROOF AFTER COMPLETION OF THE WORKS**
